# **2015 ANNUAL ENGINEERING INSPECTION REPORT**

## **ENTERGY WHITE BLUFF PLANT CLASS 3N LANDFILL**

**PERMIT NO. 0199-S3N-R3  
AFIN: 35-00110**

**JANUARY 15, 2016**

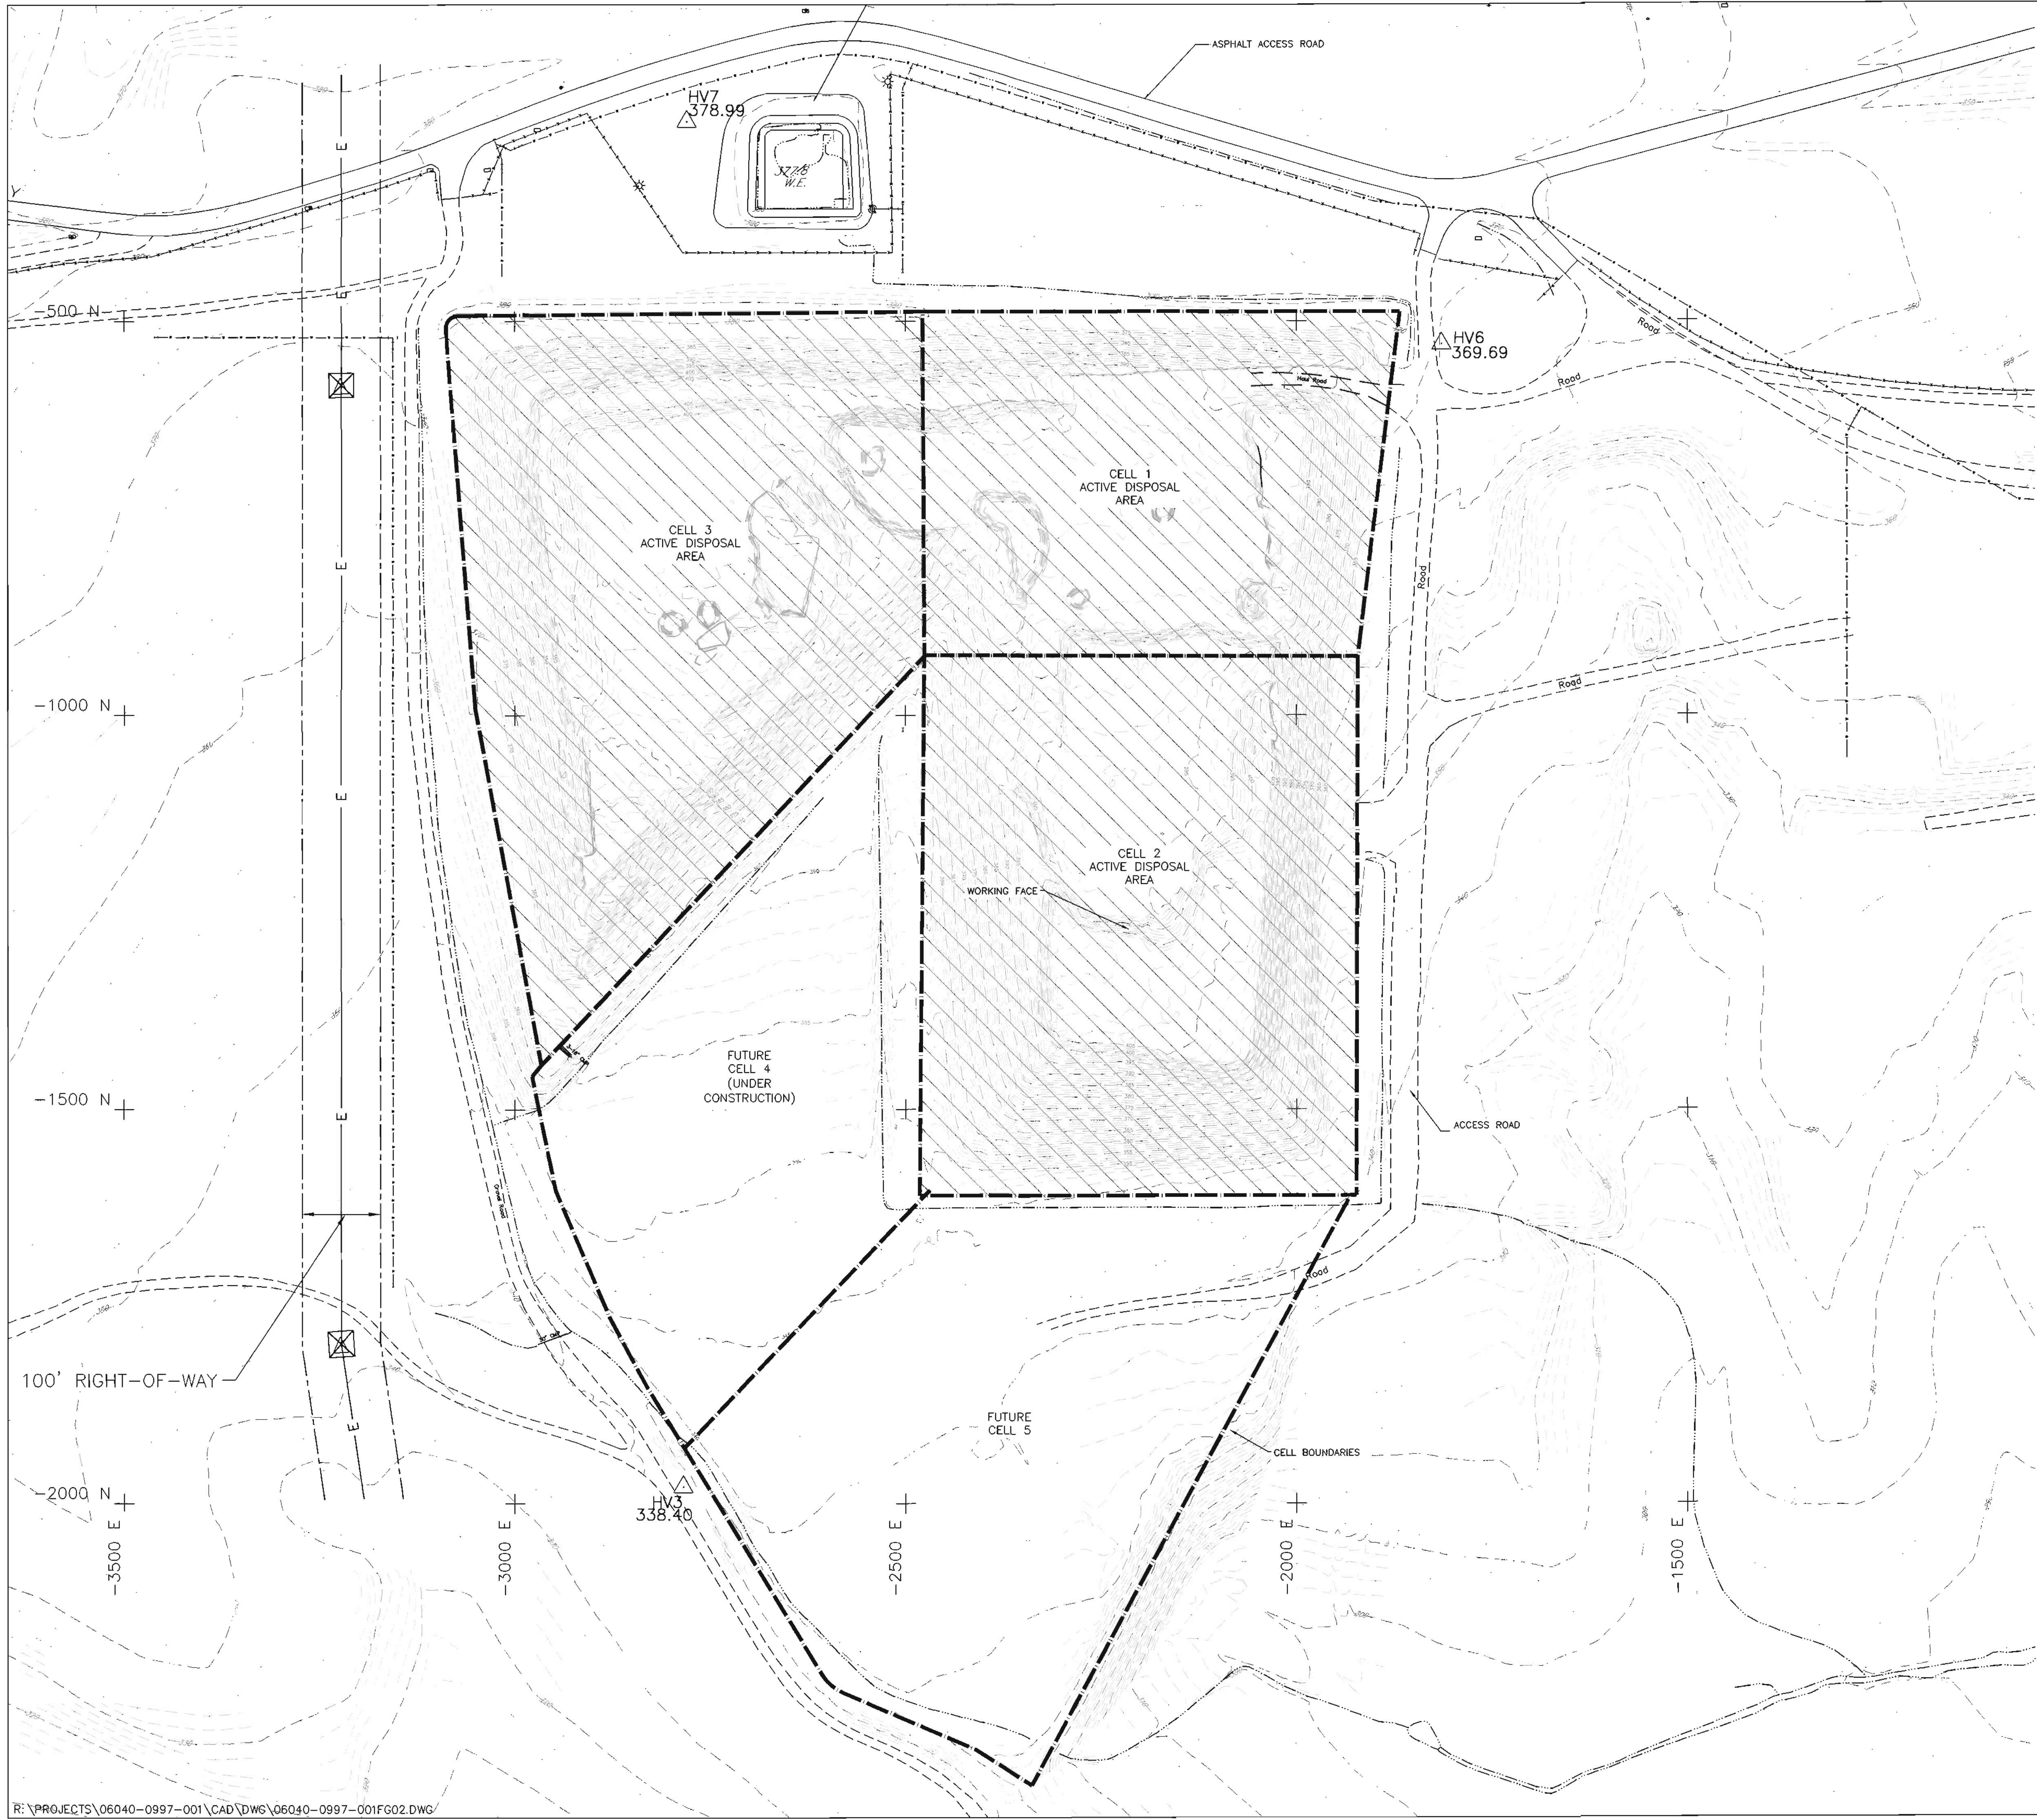
FIGURE 2  
EXISTING CONDITIONS

As noted, no final cover system has been installed on Waste Cells 1 through 3. However, as shown on Figure 2, older portions of the landfill facility that received CCR material prior to the issuance of the 2000 permit have been closed and covered in accordance with the original facility permit (1982). Figure 3 presents contours for the currently permitted final cover system.

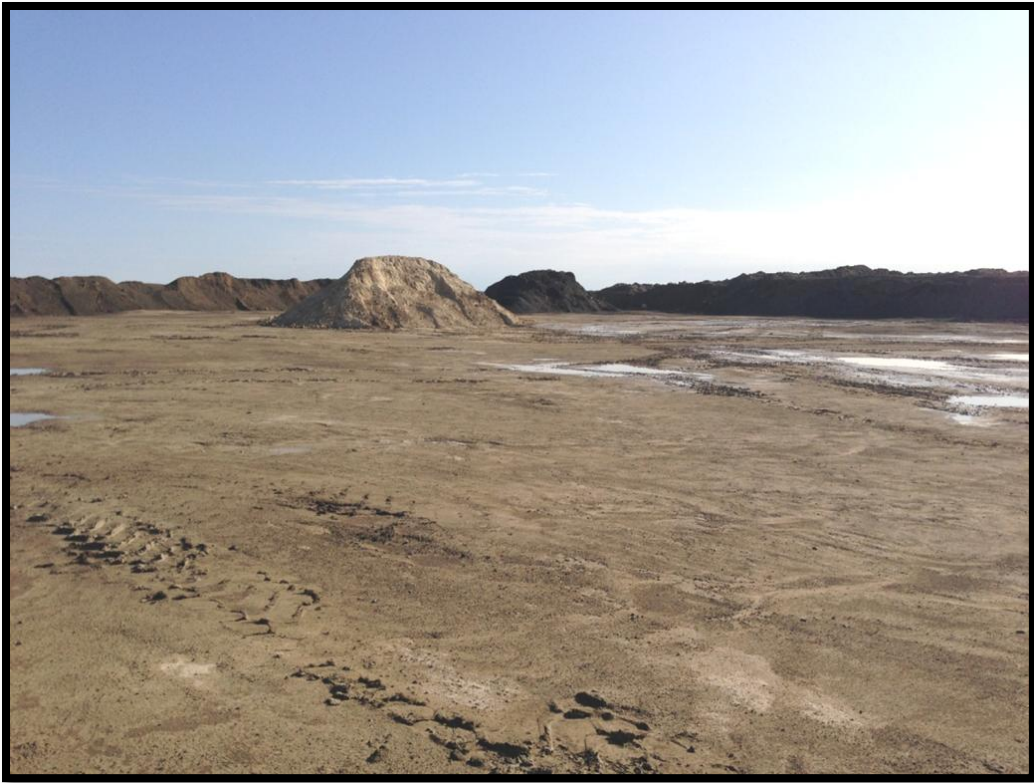
Photo 1: Top of Cell 1

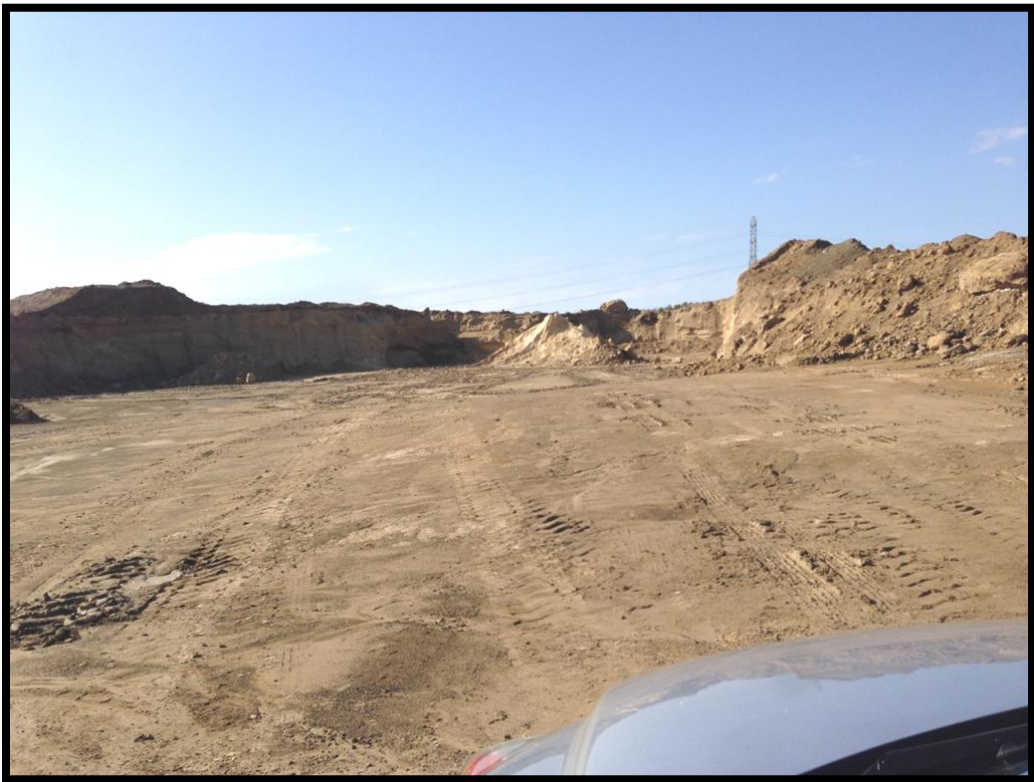
Photo 2: Perimeter berm, top of Cell 2

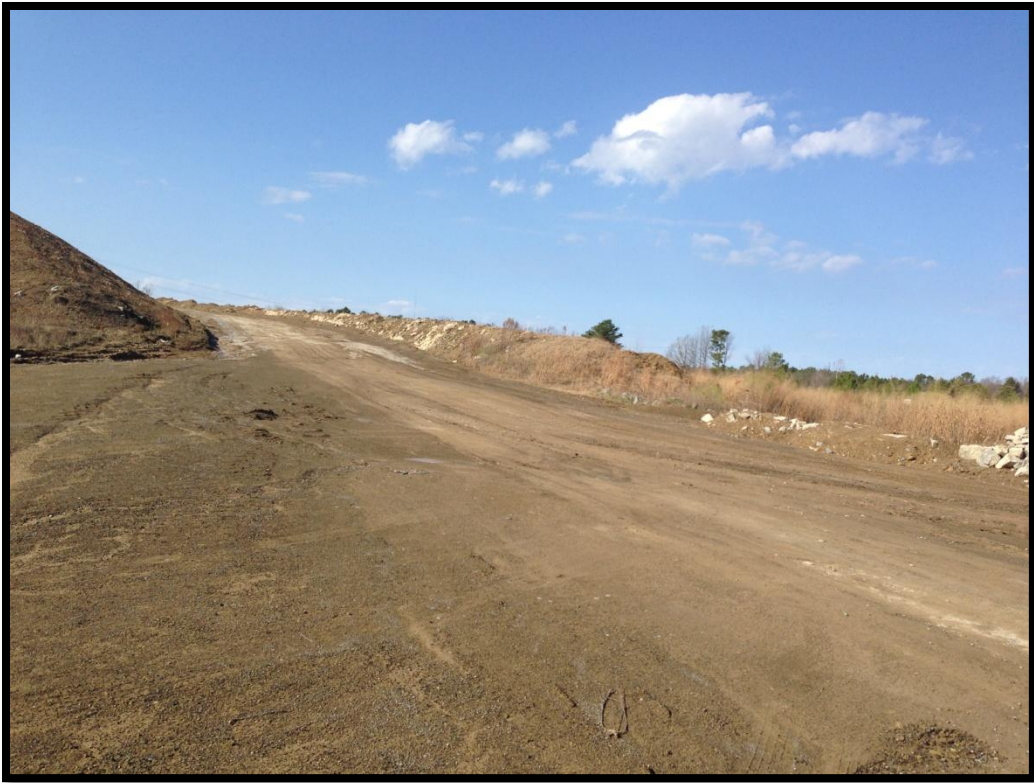
The facility roads were well maintained at the time of the inspection. The disposal access road to the active cells is paved, and it was in excellent condition at the time of the inspection. The perimeter access road has an all-weather surface course and was in good condition.

Photo 3: Access road from East

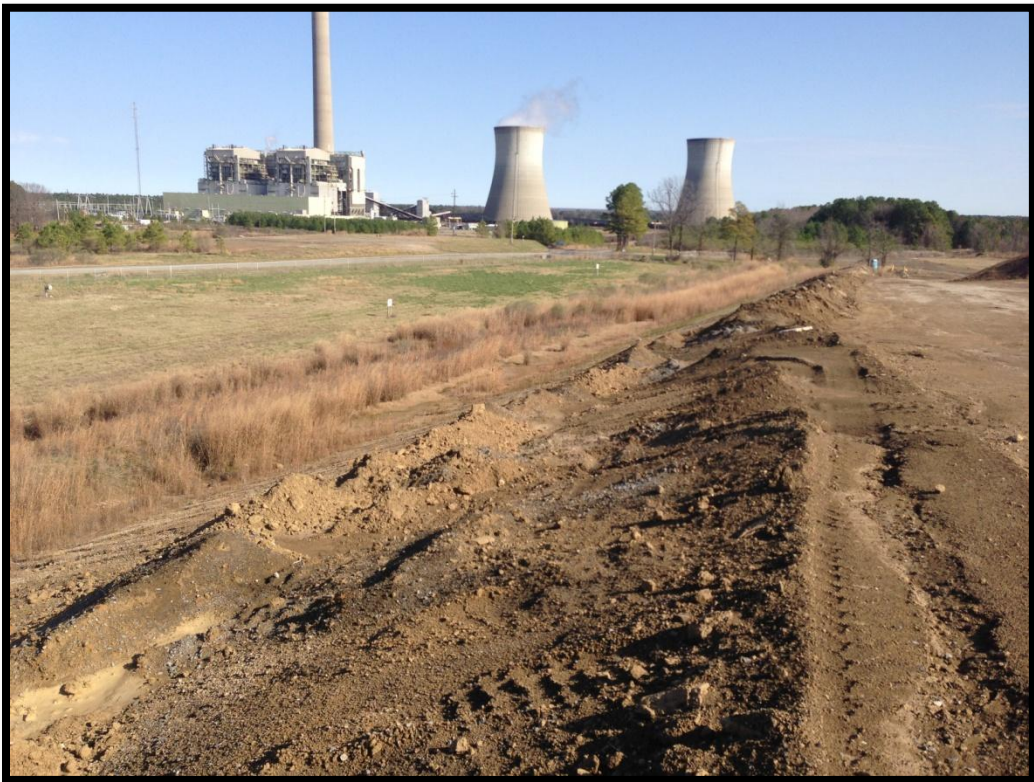
Photo 4: North slope of Cells 1 and 3, from top

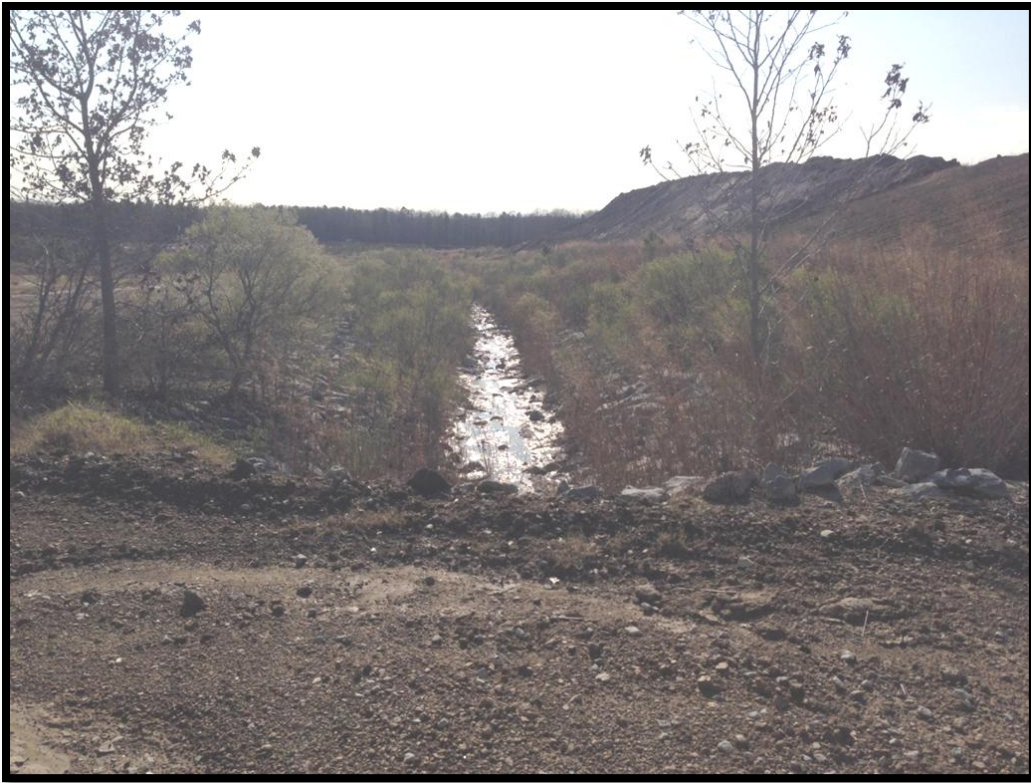
Photo 5: Stormwater drainage ditch, east slope of Cells 1 and 2

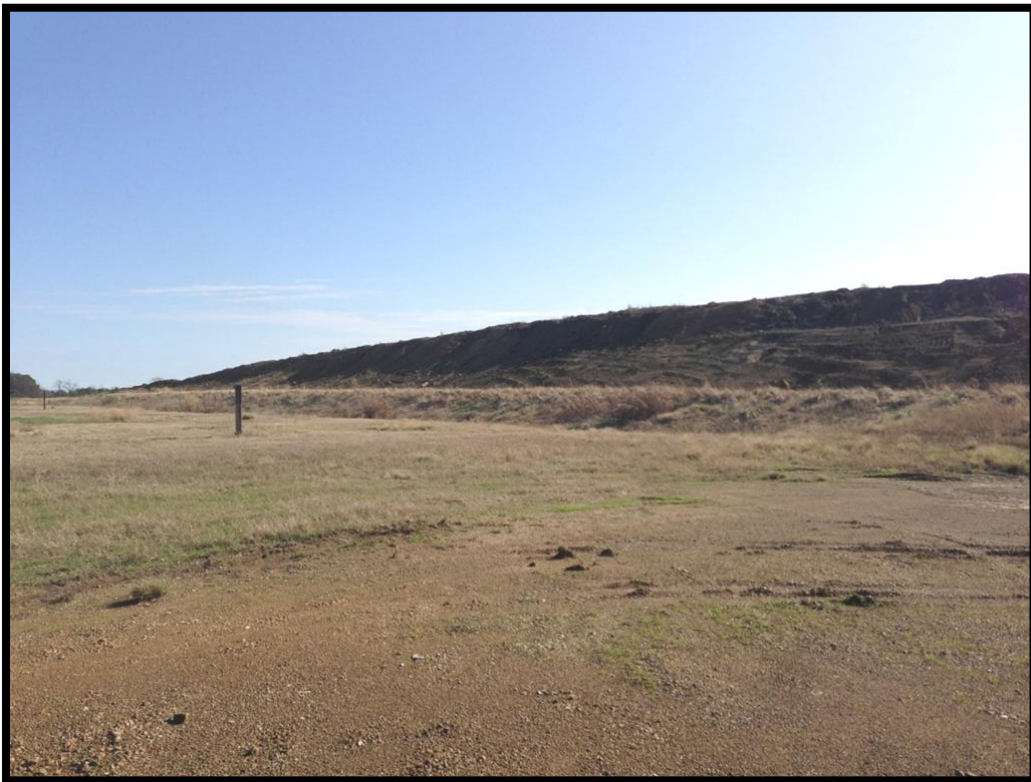
Photo 6: North slope of Cell 3 and perimeter berm from North

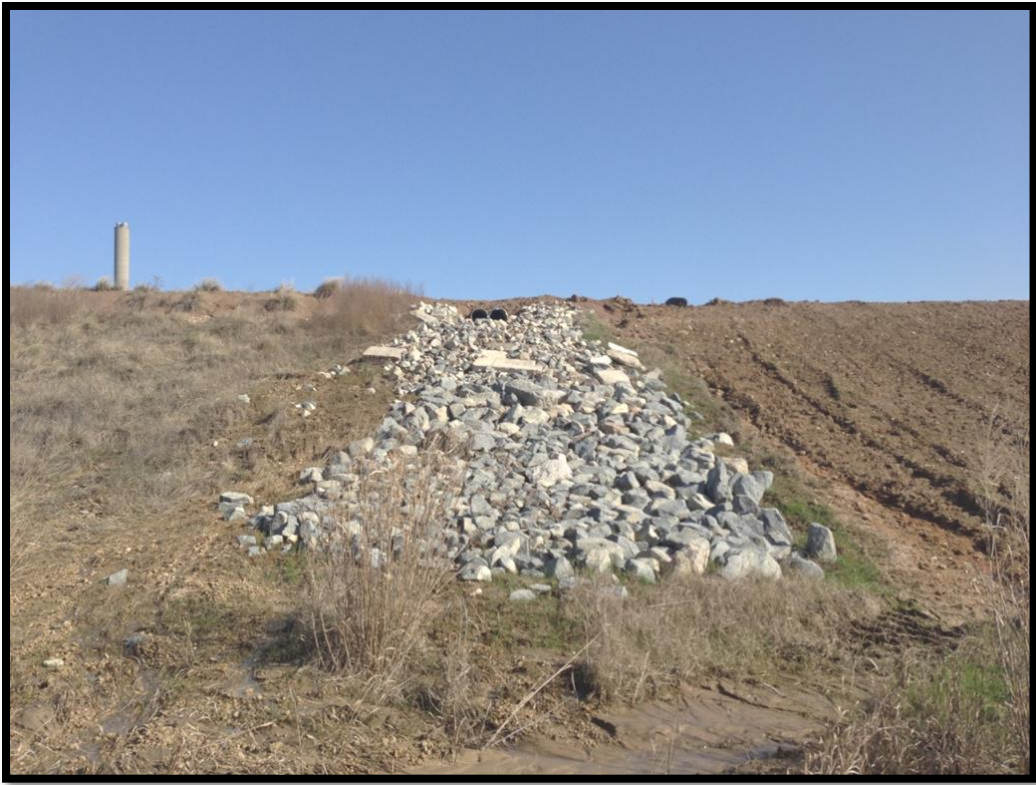
Photo 7: Riprap lined letdown, southwest of Cell 3
