2017 ANNUAL ENGINEERING INSPECTION REPORT

ENTERGY WHITE BLUFF PLANT CLASS 3N LANDFILL

**PERMIT NO. 0199-S3N-R3
AFIN: 35-00110**

**January 2018
Project No. 35177247**

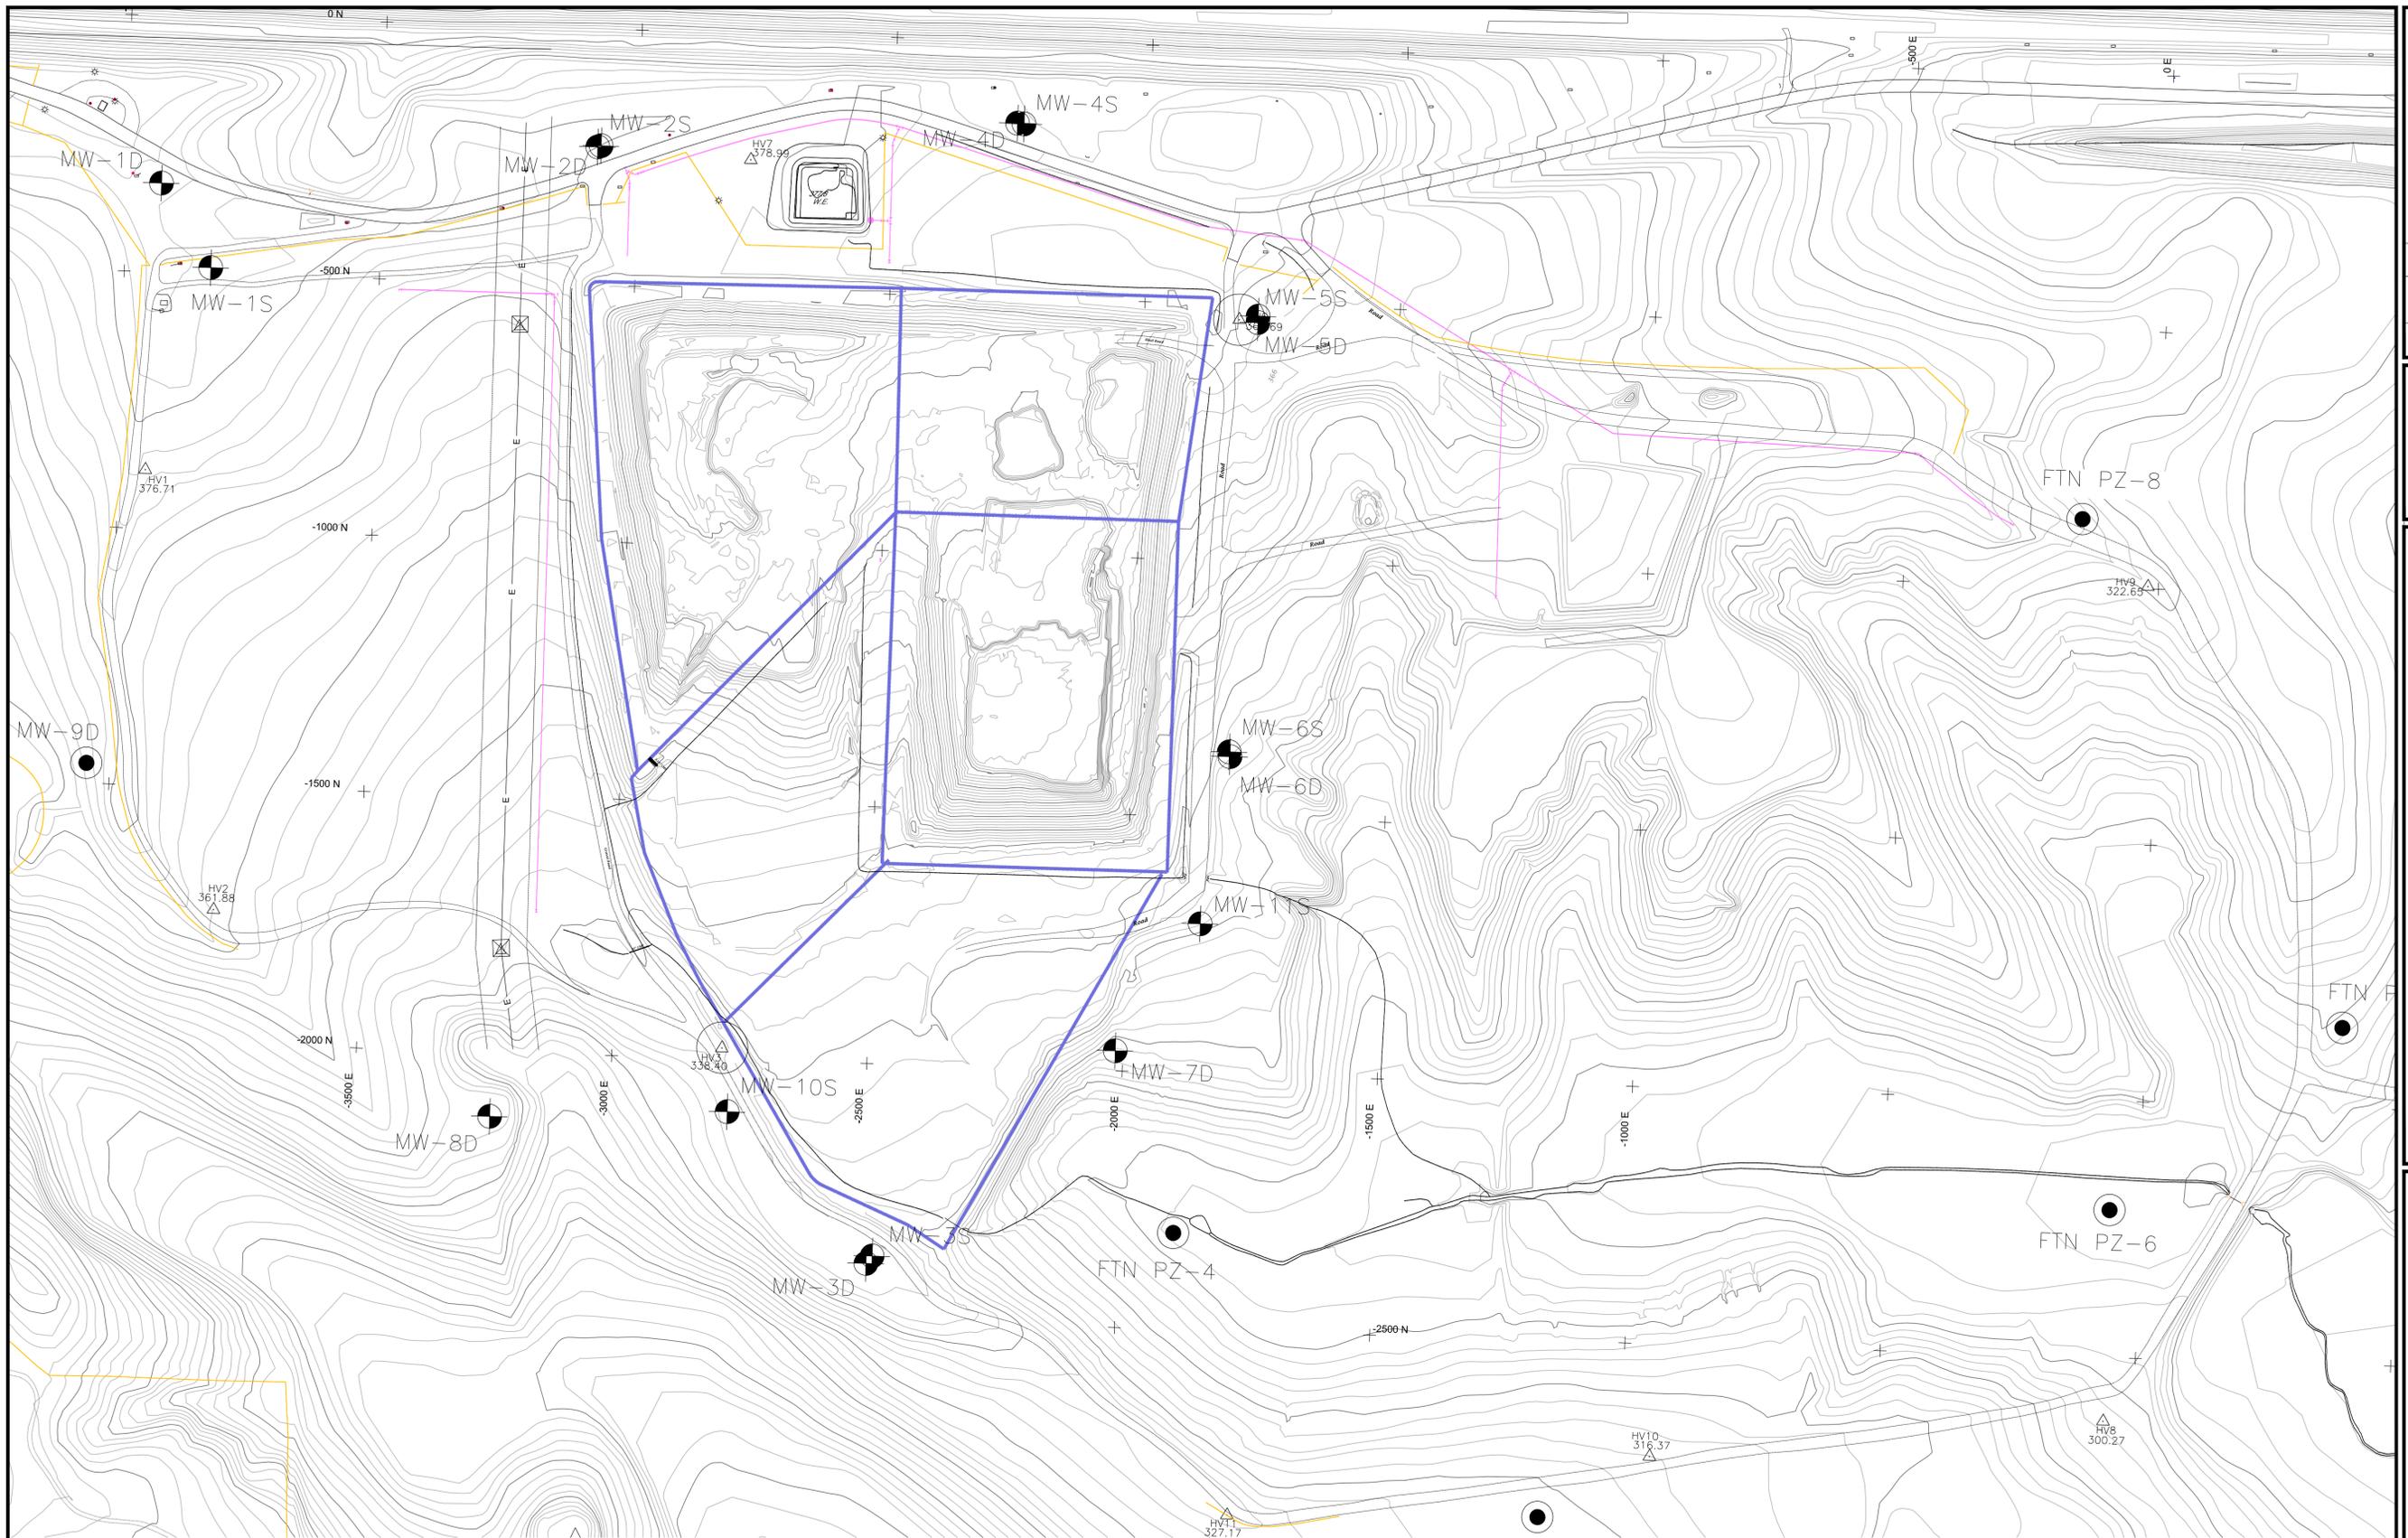
FIGURE 2

The permitted landfill area consists of approximately 177 acres (153 acres for solid waste disposal) and is located in the southwestern portion of the plant site as shown on **FIGURE 2**.

No final cover system has been installed on Waste Cells 1 through 3. As shown on **FIGURE 2**, older portions of the landfill facility that received CCR material prior to the issuance of the 2000 permit have been closed and covered in accordance with the original facility permit (1982). These areas did not receive CCR after October 2015.

EXISTING CONDITIONS

The facility finished construction of Cell 4, a 6.5-acre waste cell, in January 2016. As shown on **FIGURE 2**, Cell 4 is located south of Cell 3 and west of Cell 2. Utilization of the new cell will eventually allow waste to be placed at higher elevations in the adjacent cells, increasing the operational capacity of those cells.

As noted, no final cover system has been installed on Waste Cells 1 through 4. However, as shown on **FIGURE 2**, older portions of the landfill facility that received CCR material prior to the issuance of the 2000 permit have been closed and covered in accordance with the original facility permit (1982). **FIGURE 3** presents contours for the currently permitted final cover system.

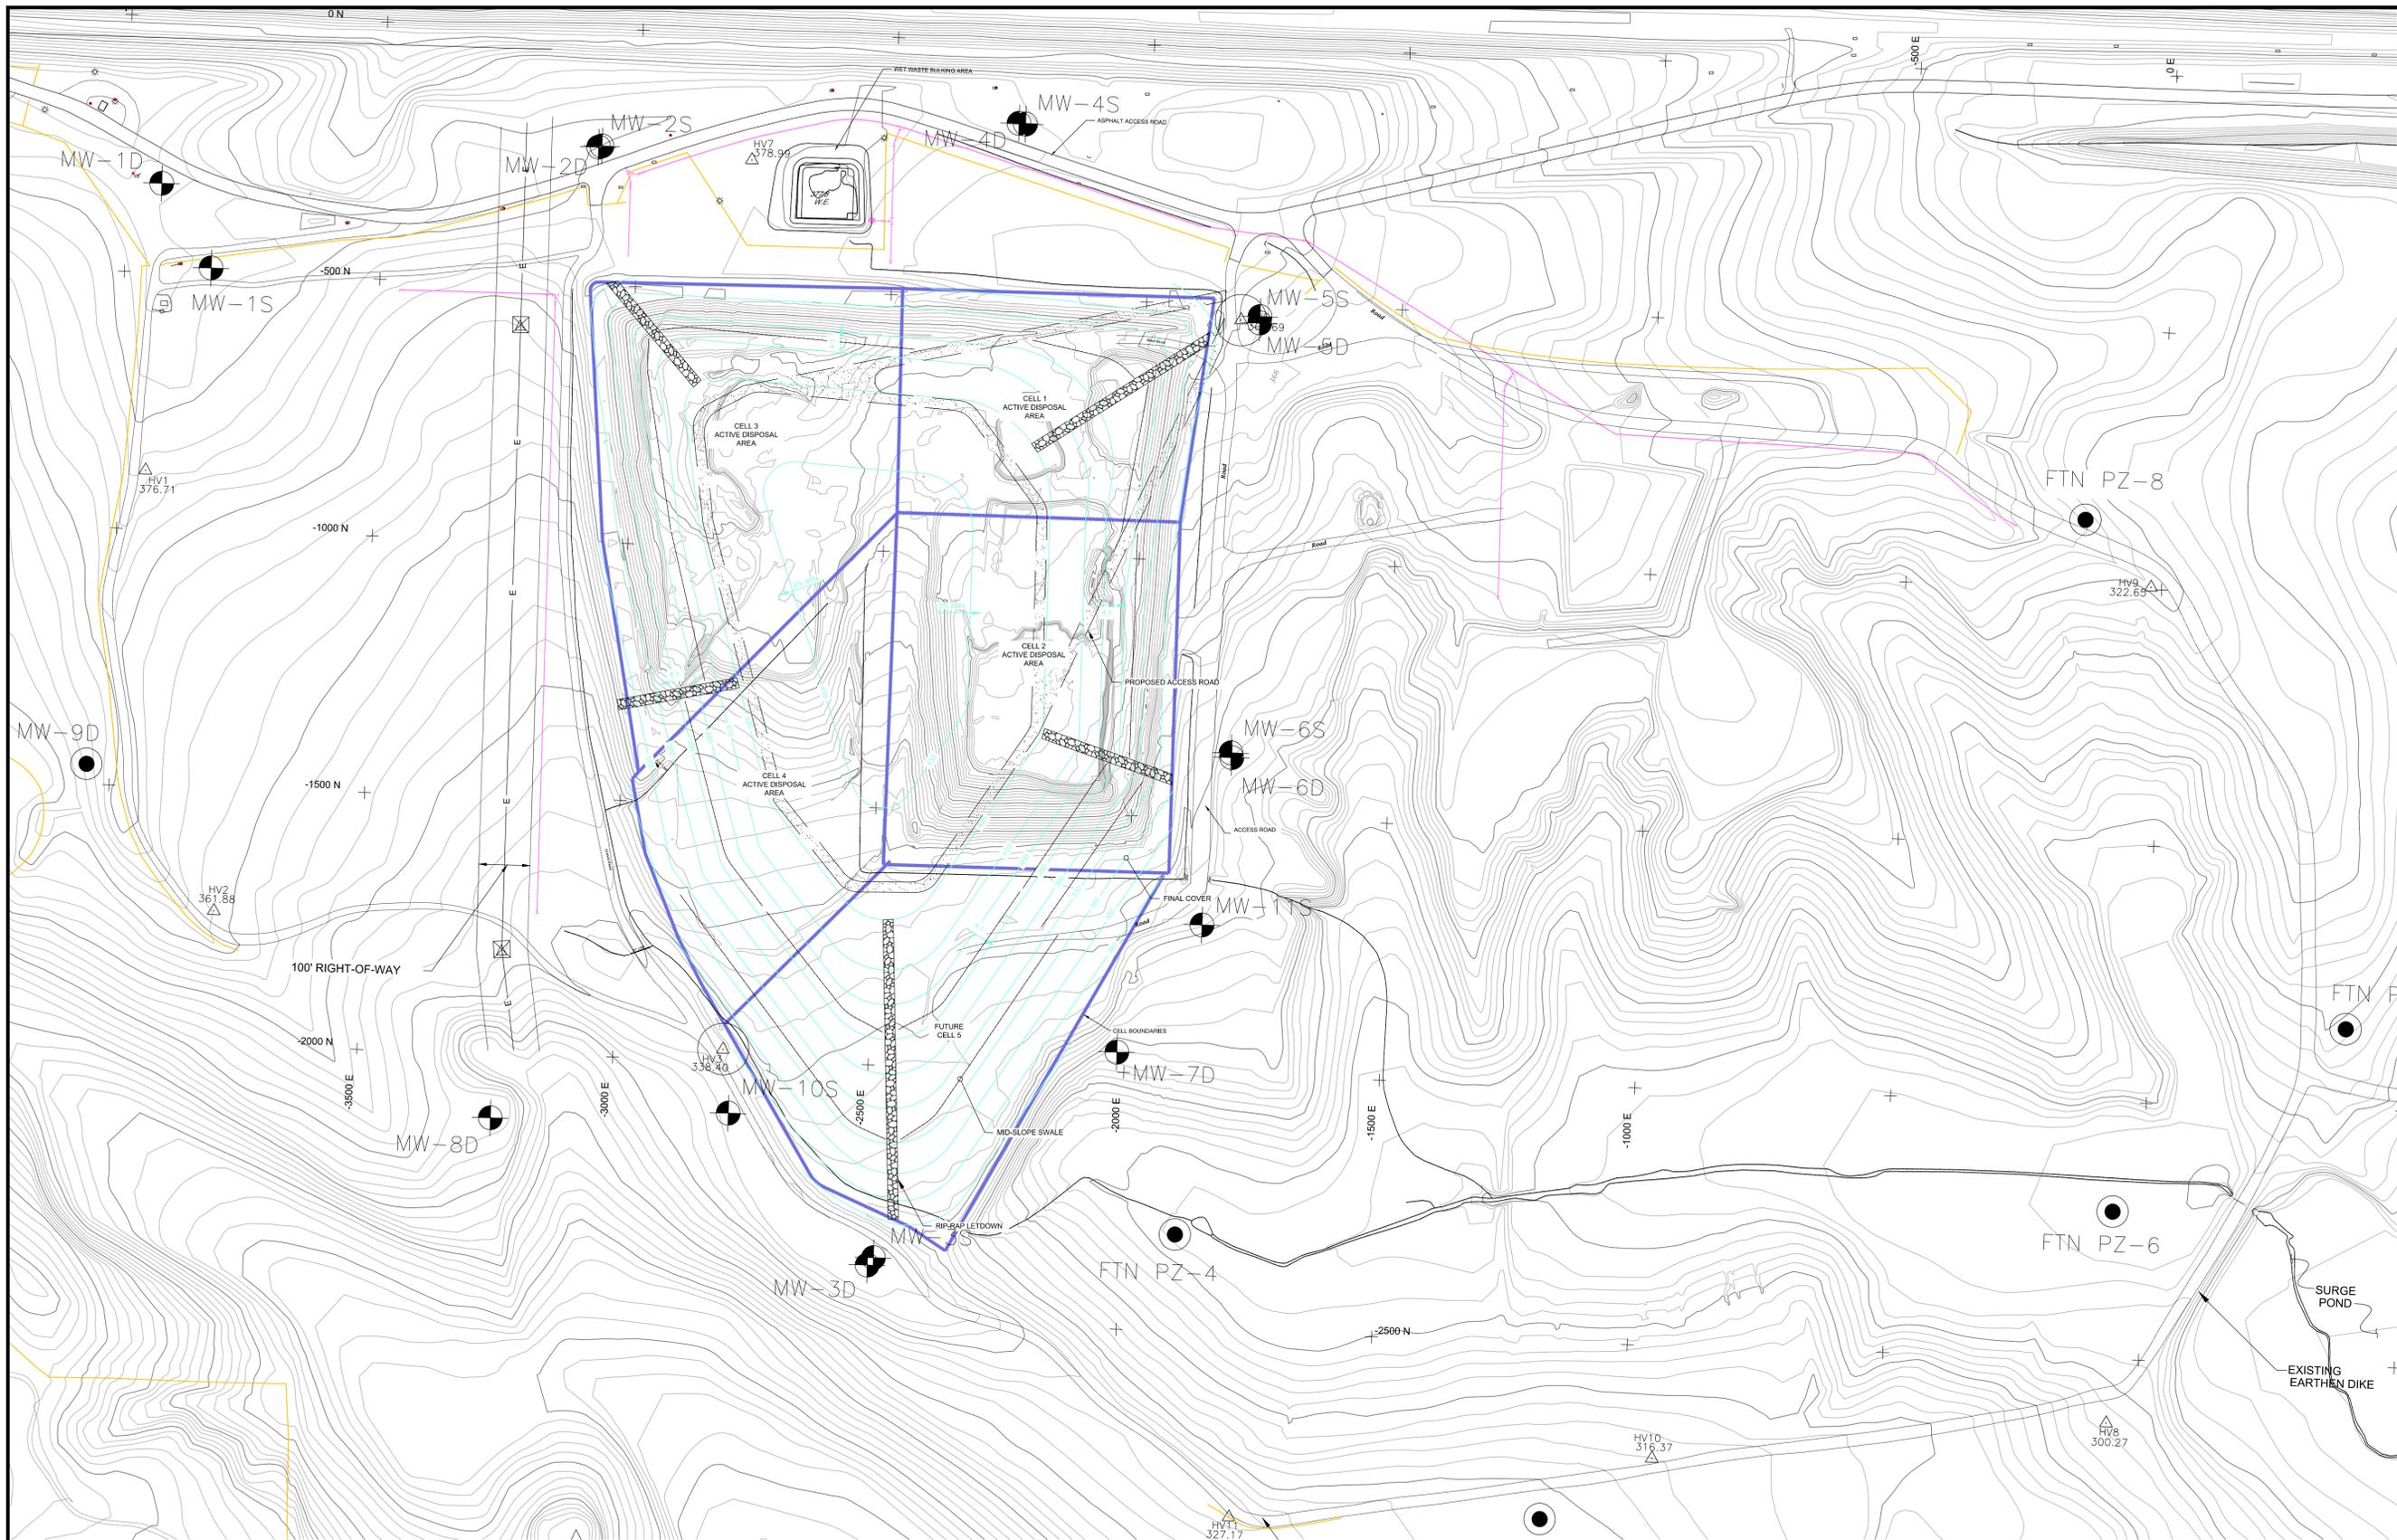
FIGURE 3

FINAL PERMIT CONTOURS
 2017 LANDFILL INSPECTION REPORT
ENERGY WHITE BLUFF PLANT
 CLASS 3N LANDFILL
 ARKANSAS
 REDFIELD

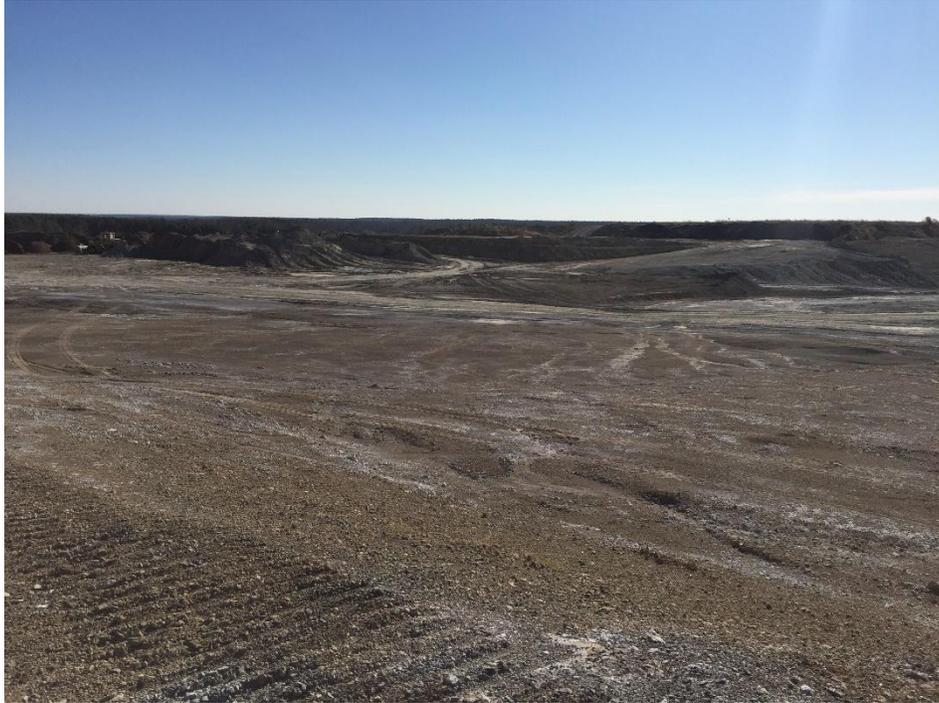
1. Top of Cell 3 looking southeast towards Cell 1.

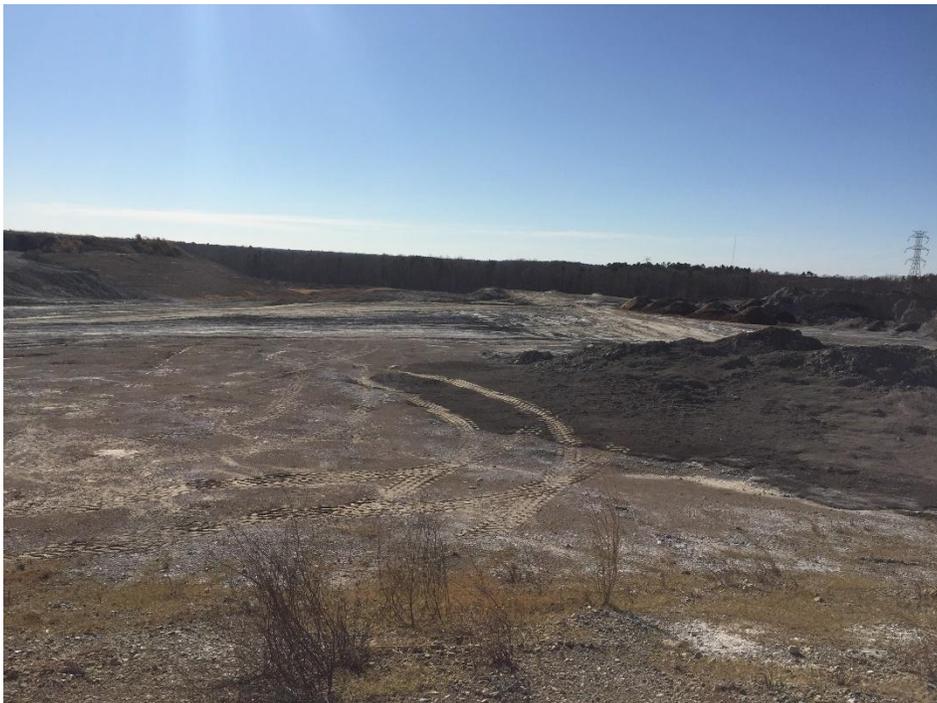
2. Top of Cell 3 looking southwest.

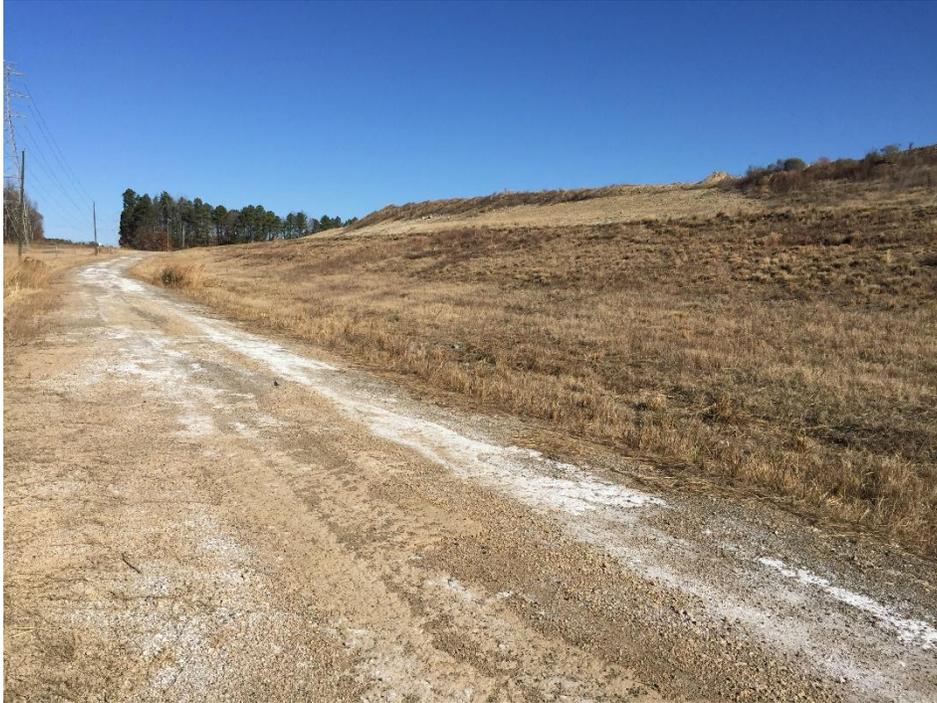
No tension cracks, seeps, or other features that indicate a potential slope failure were observed during the site inspection. In addition, no active seeps were noted

3. The west sideslope of Cell 3.

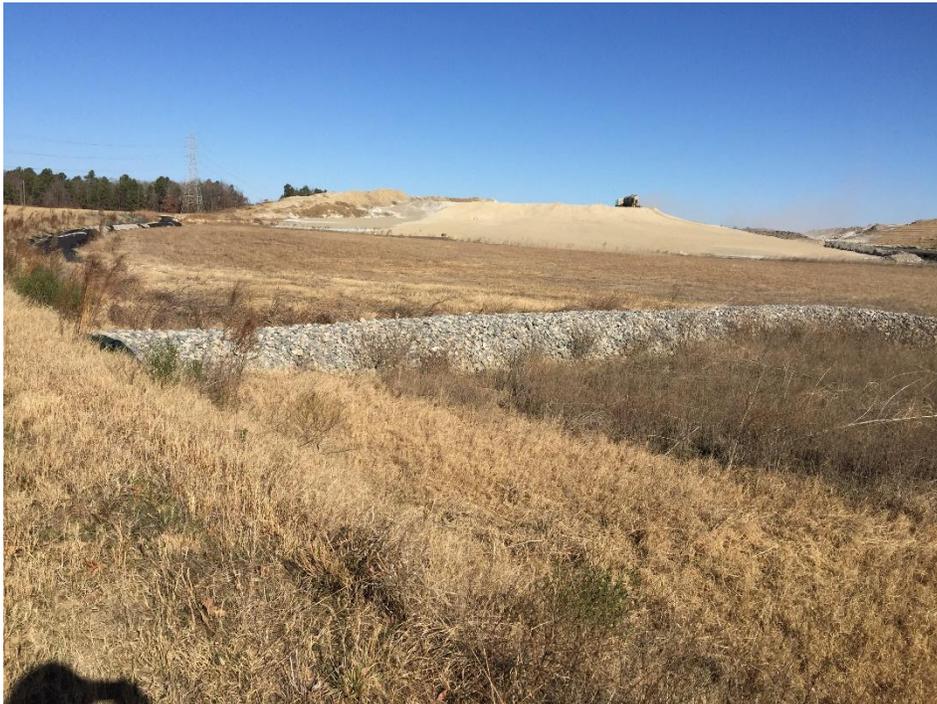
4. The southeast side of Cell 4 looking to the North.

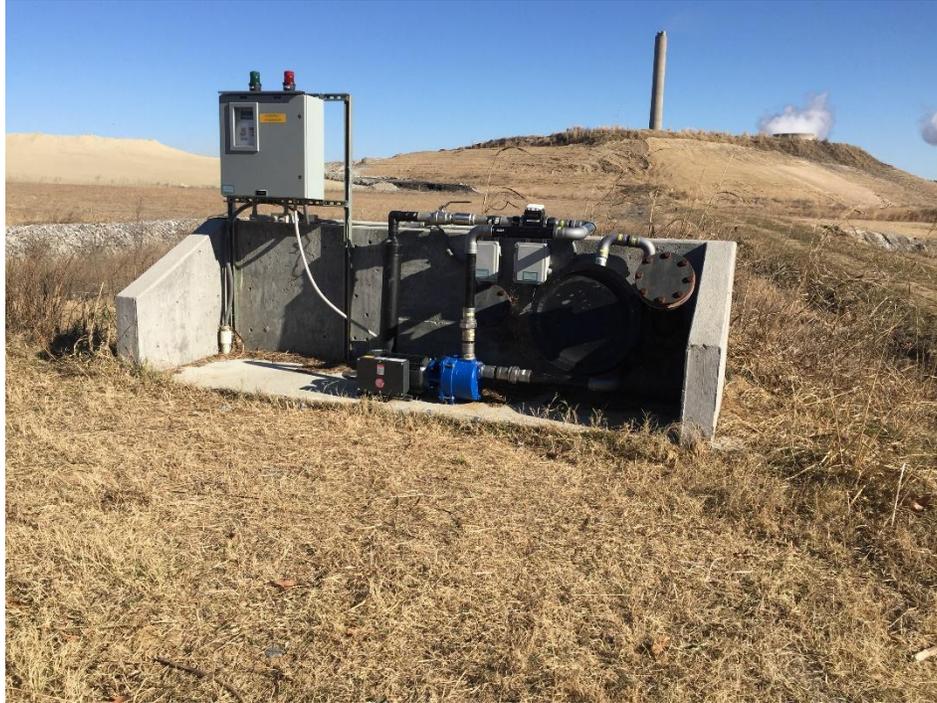
Cell 4 was designed with leachate collection and transmission systems. Additionally, new collection lines were installed along the west and south sides of the existing Cell 3. These new collection lines were connected to the new Cell 4 leachate collection system, which was designed to handle leachate from both cells. The automated pumping system will remove the Cell 3 and Cell 4 leachate from a sump in the southwest corner of Cell 4. The leachate is pumped via a dual-contained underground pipeline and discharged to the plant's Surge Pond. During the site inspection the leachate sump was in working order and the leachate levels were below the 36-inches allowed.

5. Leachate pumping system on the southeast corner of Cell 4.

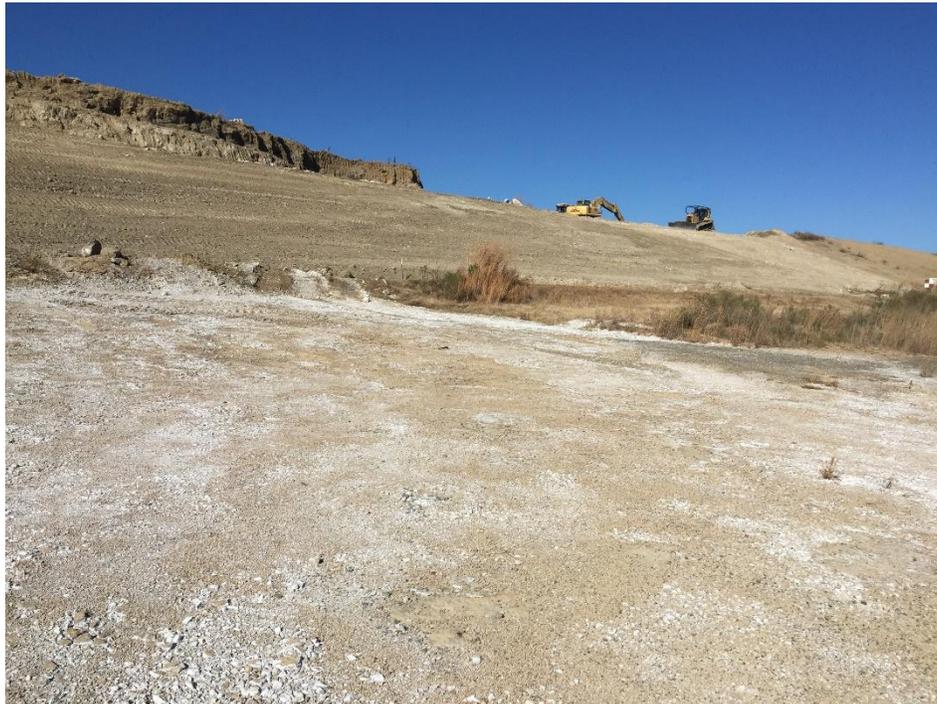
6. East slope of Cells 1 & 2 looking to the northwest.
