2020 Landfill CCR Inspection Report

Entergy Arkansas, LLC White Bluff Plant
Class 3N Landfill
Redfield, Arkansas

Permit No. 0199-S3N-R3
AFIN: 35-00110

January 2021
Project No. 35207213

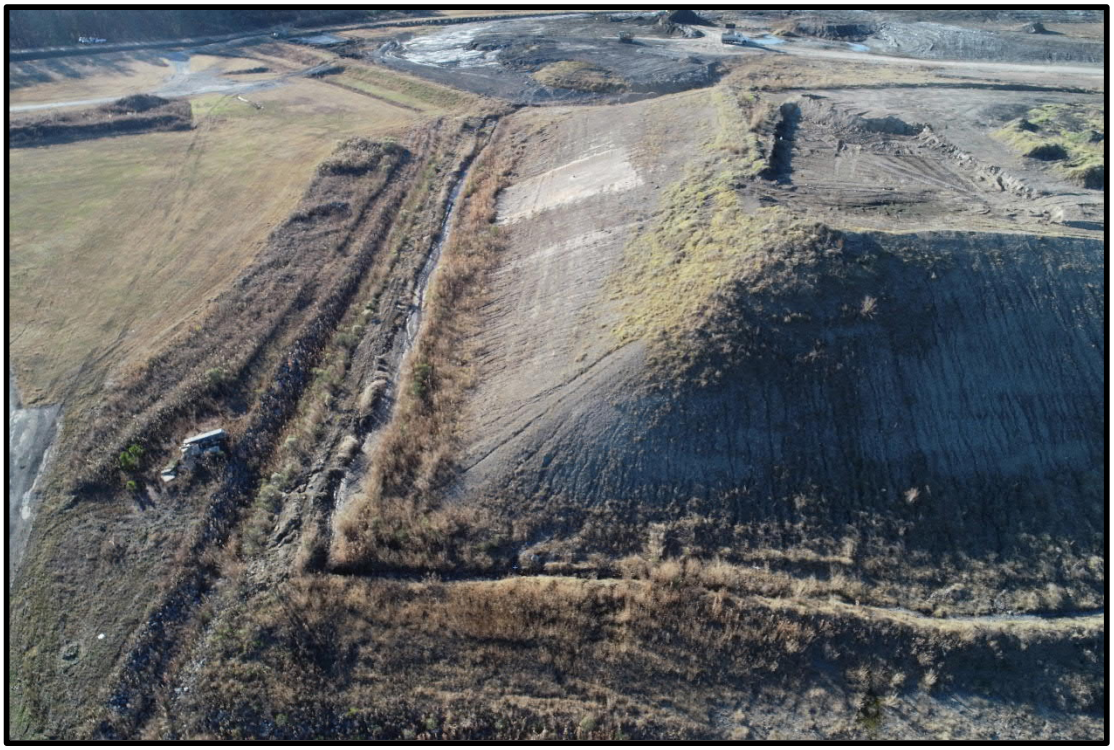
2. Looking at east slope of Cell Waste 2.
